The Role of Radiology in Detecting Prosthetic Breast Implant-Related Complications

Willian Schmitt, João Morais Coelho, João Lopes, José Carlos Marques

Serviço de Radiologia, Hospital Prof. Doutor
Fernando Fonseca, Amadora, Portugal

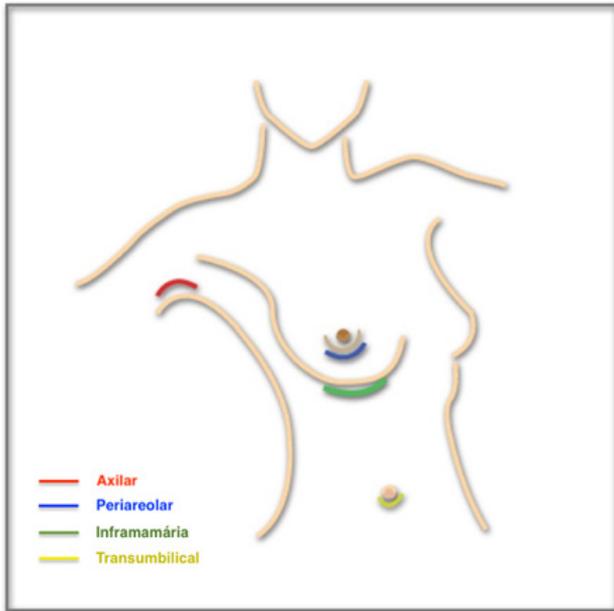
Figure 1 – Illustration of different types of incision.

The surgical technique, namely the type of incision and the plane of dissection, is individualized and performed according to the anatomy and the preferences of each patient, the experience of the surgeon and the type of surgery (aesthetic or reconstructive, primary or revision). In breast augmentation mammoplasty the different types of approach are: inframammary, periareolar, transaxillary or, rarely, transumbilical (Figure 1).

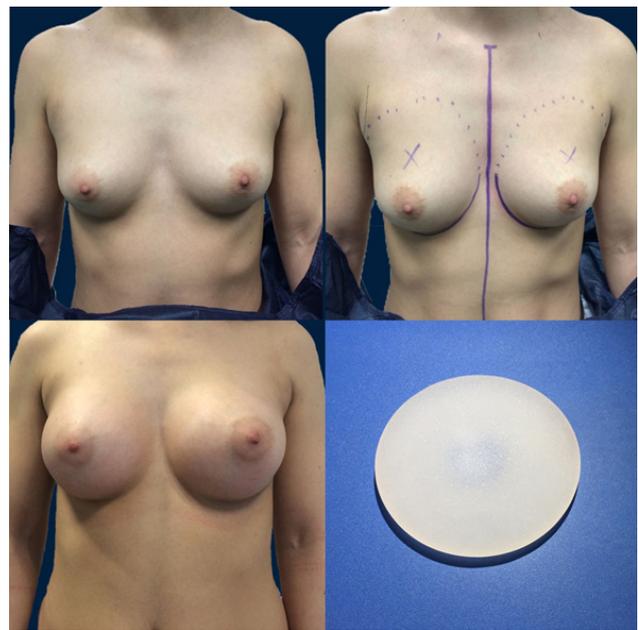
Figure 3 – Pre and post surgery of breast augmentation mammoplasty with a retroglandular textured silicone implant placed by inframammary approach

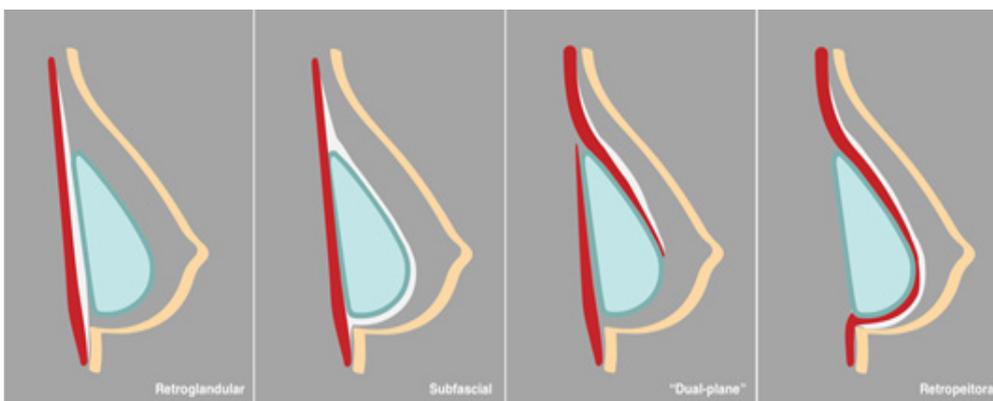
Figure 2 – Illustration of various dissection planes.

Breast implants can be placed in several planes of dissection: retro-glandular, subfascial, retro-pectoral or in “dual-plane” (Figure 2).

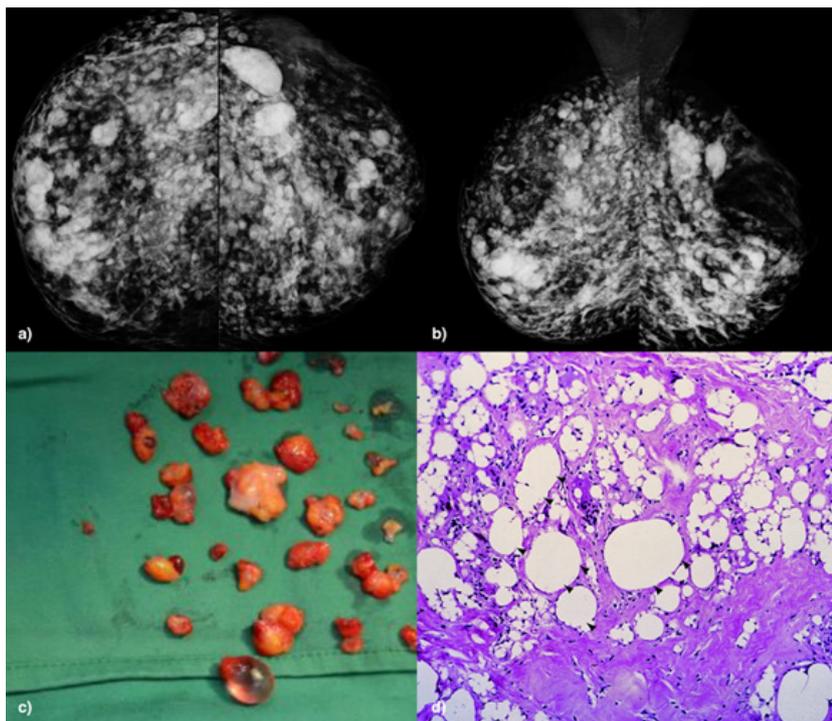
Figure 4 – A woman with a history of free silicone injection, showing the presence of multiple silicone granulomas (siliconomas), bilaterally, evidenced in the mammographic study (a and b), macroscopic (c) and histological (d) ones.

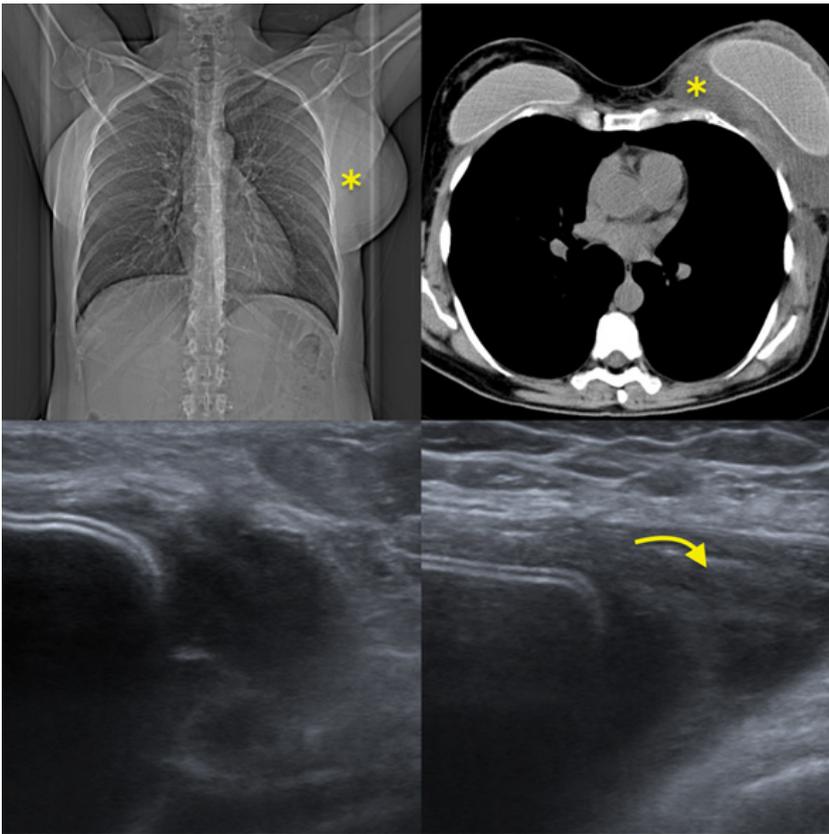
Figure 5 – A 46-year-old female submitted to augmentation mammoplasty, with markedly developed breast asymmetry during the postoperative period. The tomodensitometric study revealed the presence of voluminous periprosthetic collection (asterisk), translated in the ultrasound study by multiseptated collection suggestive of hematoma. An eco-guided drainage of this hematoma was performed, with a favorable evolution of the clinical picture.

Hematoma formation often occurs in the immediate postoperative or post-trauma period. The mammographic study may show the presence of a well-defined hyperdense area, while the ultrasound study reveals the presence of a heterogeneous, multi-segmented collection (Figure 5).

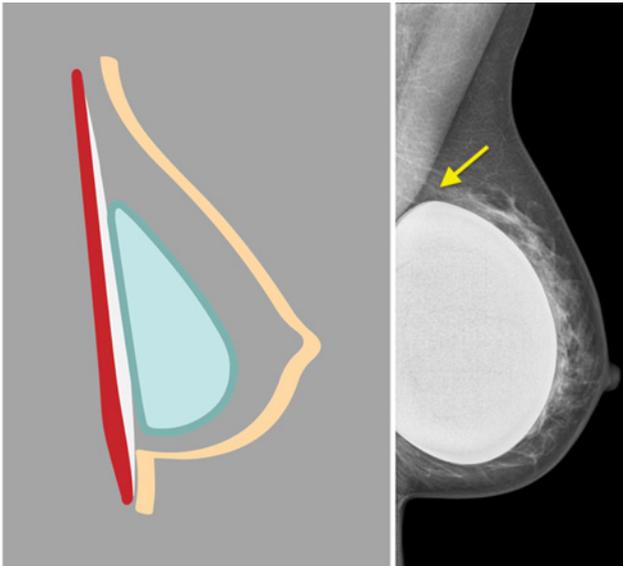
Figure 6 – Illustration and mammographic study on the mid-lateral-oblique incidence (MLO) demonstrating the presence of a silicone implant located in the subglandular plane, anterior to the pectoral muscle (arrow).

First, the location of the prostheses should be recognized, followed by analysis of their contours (Figures 6 and 7).

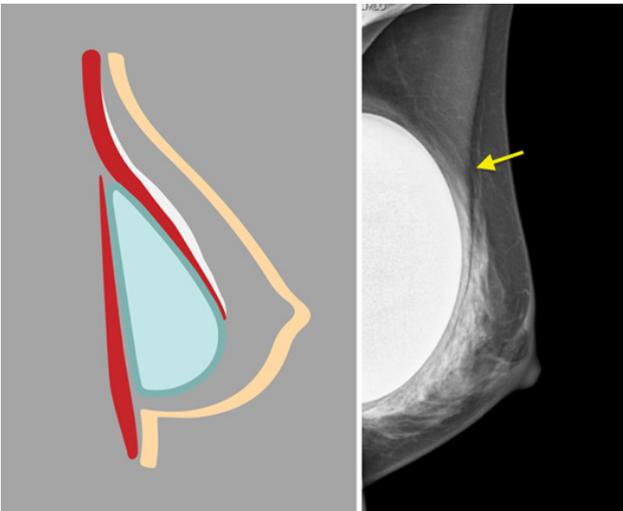
Figure 7 – Illustration and mammographic study on the MLO incidence of retromuscular silicone implant (arrow), in this case in “dual-plane”, only with partial dissection of the pectoralis major muscle.

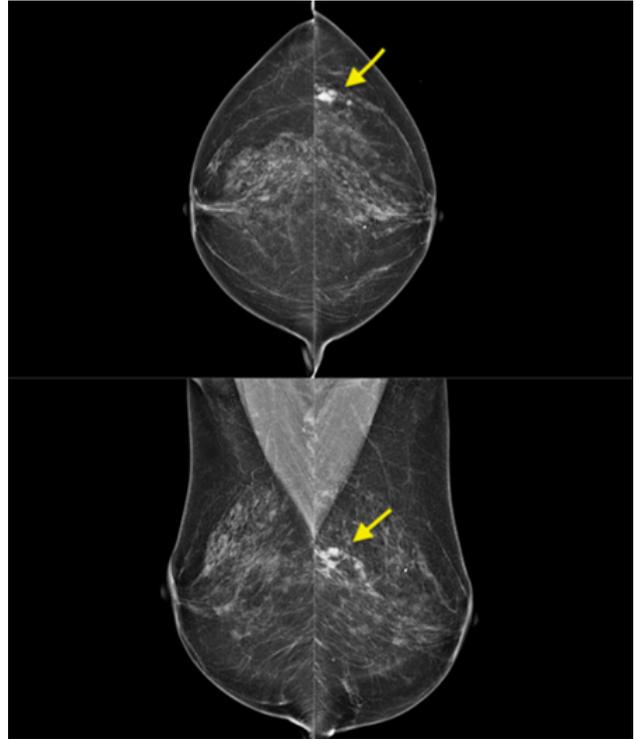
Figure 8 – A 75-year-old woman with a history of reduction mammoplasty with implant complications. The mammographic study revealed the presence of a high density asymmetry in the super-external quadrant of the left breast.

Although little sensitive in the detection of intracapsular rupture, the mammography is very useful in the detecting extracapsular silicone, represented by the presence of a high density asymmetry in the parenchyma (Figures 8 and 9).

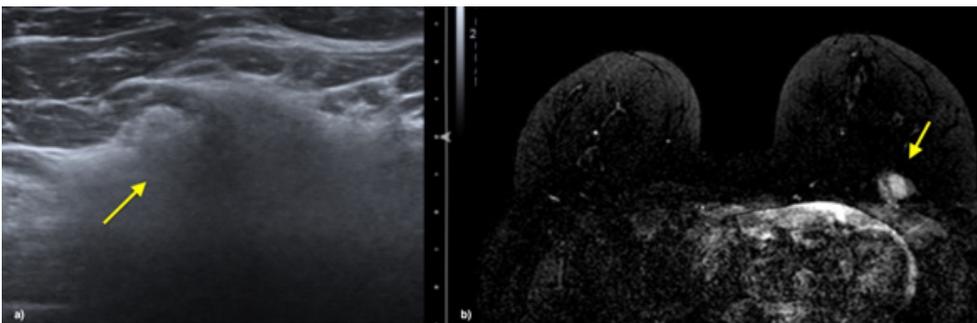
Figure 9 – A complementary ultrasound study (a), which demonstrated the presence of the “snowstorm” signal was performed, and the MRI (b) study revealed the presence of hypersignal in the selective sequence for the silicone. These findings are compatible with free silicone, these characteristics being described later in this article.

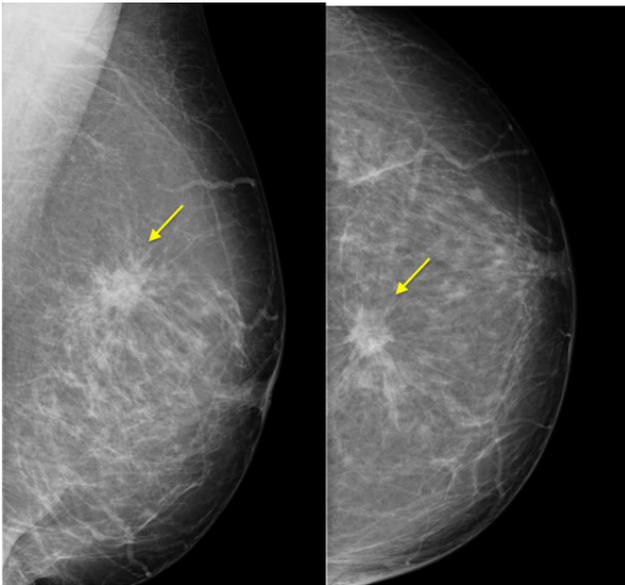
Figure 10 – Woman with a history of implants removal due to complication. The mammographic study revealed the presence of a suspicious lesion, with spiculated contours, and the biopsy result was negative. The MRI study revealed the presence of a non-capturing lesion, with a positive sign for silicone.

Sometimes the extracapsular silicone can simulate larger lesions, forming granulomas, which may have spiculated contours. In these cases, a high level of suspicion is necessary in order to avoid unnecessary biopsies (Figure 10).

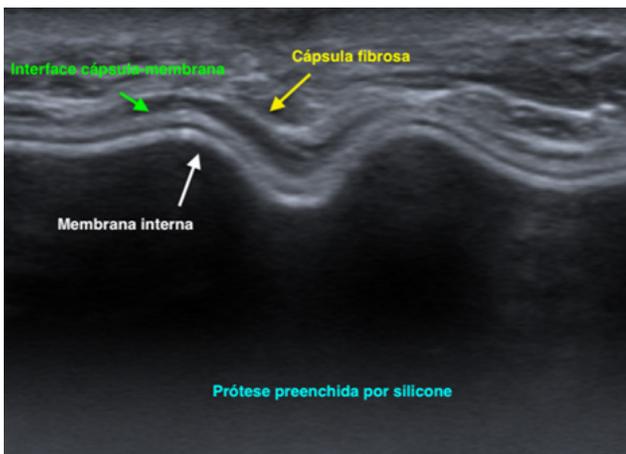
Figure 11 – Ultrasound study showing external trilaminar line of a silicone implant.

The knowledge of the normal ultrasound aspect of the breast implants is fundamental in their evaluation. These are externally delimited by a regular trilaminar line, which progressively molds to the loca created during the surgical procedure, forming radiating folds, which should not be mistaken for signs of intracapsular rupture. This outer trilaminar contour is formed externally by a hyperechogenic line, which represents the outer face of the fibrous capsule, an innermost line representing the inner face of the elastomer shell and an intermediate line that translates the interface of these two components (Figure 11).

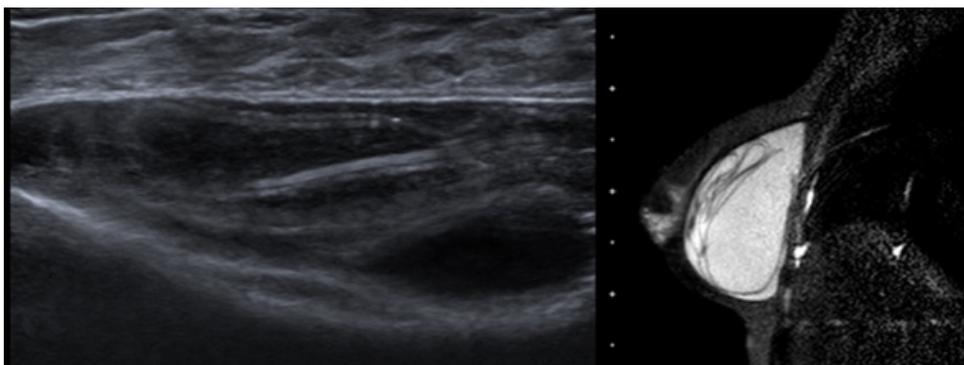
Figure 12 – A 40-year-old woman with a history of breast augmentation 12 years ago. The ultrasound study demonstrated the presence of several curvilinear lines inside the implant (ladder sign), in correspondence with the “linguini” sign in MRI, translating the presence of intracapsular rupture.

The presence of several horizontal or curvilinear lines inside the implant, forming the stepladder sign, are the most reliable sign of intracapsular rupture, in which there is a greater collapse of the envelope, being equivalent to the sign of the “linguini” on MRI (Figure 12).⁸

The presence of intracapsular rupture is more easily detected through this imaging method. The most reliable finding of this complication is the “linguini signal”, described by Gorczyca et al., in 1992, with a sensitivity and specificity of 96% and 77% respectively.²¹ This signal consists of a late stage of this type of rupture, associated with partial or total collapse of the elastomer shell. Imaging is represented by the presence of multiple hypointense curvilinear lines within the hyperintense contents of the implant (Figures 12 and 21).

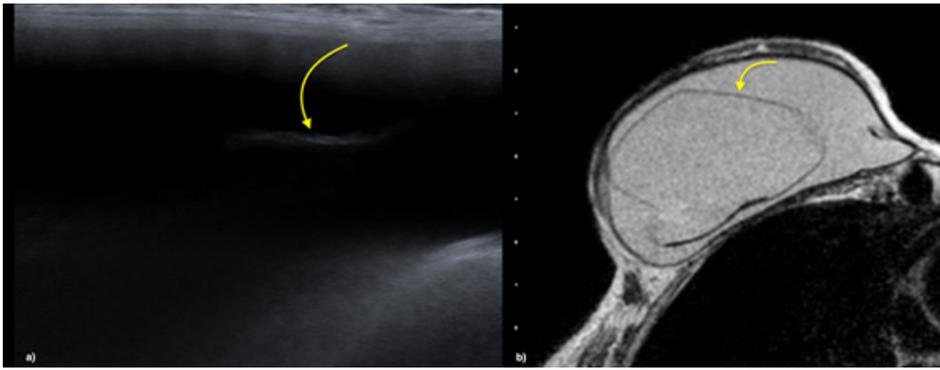
Figure 13 – An 85-year-old woman with a history of bilateral mastectomy for bilateral breast carcinoma and reconstruction with implants 20 years ago. In the ultrasound study (a) the loss of the usual trilaminar contour was verified, identifying the presence of the “subcapsular line” signal (arrow). The MRI study was consistent (b), revealing detachment of the internal membrane of the implant, being compatible with intracapsular rupture. This should not be mistaken with the presence of periprosthetic fluid, reason why it is crucial to evaluate the trilaminar line.

Other signs such as the “lock sign” or the “subcapsular line” should also alert the radiologist to the presence of this type of rupture, representing earlier stages of the rupture. The lock sign occurs by expanding the apex of a radiating fold by extruding a small amount of silicone at this level. The sign from the subcapsular line represents a slightly posterior stage, where there is a greater accumulation of silicone in the space between the fibrous capsule and the inner membrane (Figure 13).

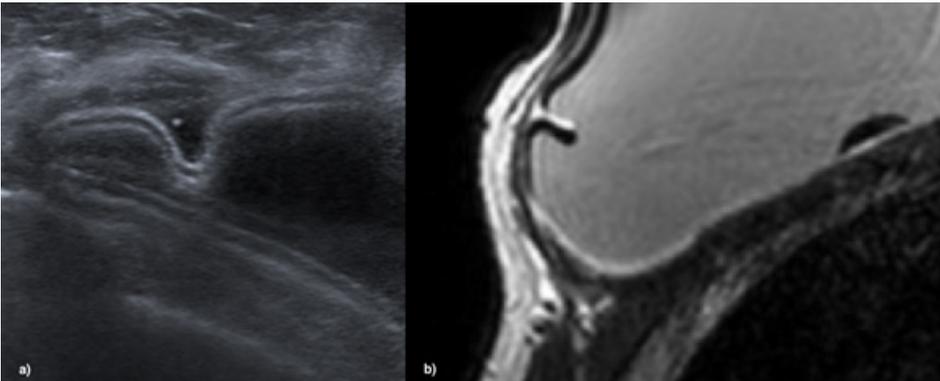
Figure 14 – Ultrasound (a) and MRI (b) showing the presence of a radiating fold.

The presence of a heterogeneous content may simulate the presence of rupture, especially in the 5th generation implants with silicon gel of high cohesiveness. Radial folds may also mimic this type of complication, however, since they represent only an invagination of the envelope, it is important to follow the path from the apex to the margin of the implant (Figure 14).

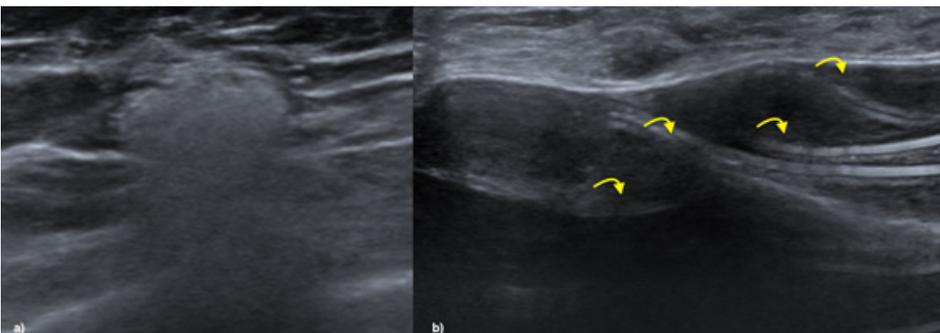
Figure 15 – A 40-year-old woman with a history of breast augmentation. The ultrasound study identified the presence of axillary ganglion with sign of the “snowstorm”, suggestive of extracapsular rupture, confirmed by the presence of the “ladder” sign in the homolateral implant, translating intracapsular rupture.

The presence of any signs suggesting intracapsular rupture should alert the radiologist to the eventual presence of associated extracapsular rupture. For this, the presence of free silicone in the mammary parenchyma, translated by the sign of the “snowstorm”, the most sensitive and specific signal of rupture on the ultrasound,¹⁴ should be investigated. This consists of a marked increase in echogenicity with loss of the parenchymal interface, conditioned by the dispersion of the ultrasonic beam caused by the silicone. The free silicon can still be absorbed by the lymphatic system, identifying the presence of this same sign in the axillary ganglia. As previously described, its presence is not diagnostic of rupture due to the existence of the gel-bleeding phenomenon, which is currently less frequent with the use of the latest generation silicone implants (Figure 15).

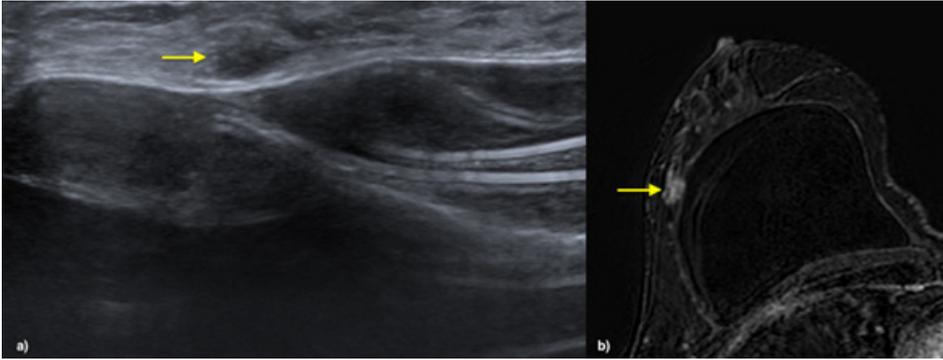
Figure 16 – The same ultrasound study (Figure 15) also revealed the presence of a nodule with indeterminate ultrasound characteristics, and a complementary MRI study was performed. In the study of MR (b), this presented enhancement after administration of contrast, and a directed biopsy was performed, which revealed that it was a foreign body granuloma.

If the ultrasound findings are not categorical or if the evaluation has been impaired by the presence of granulomas related to previous ruptures, a complementary MRI study should be performed (Figure 16).

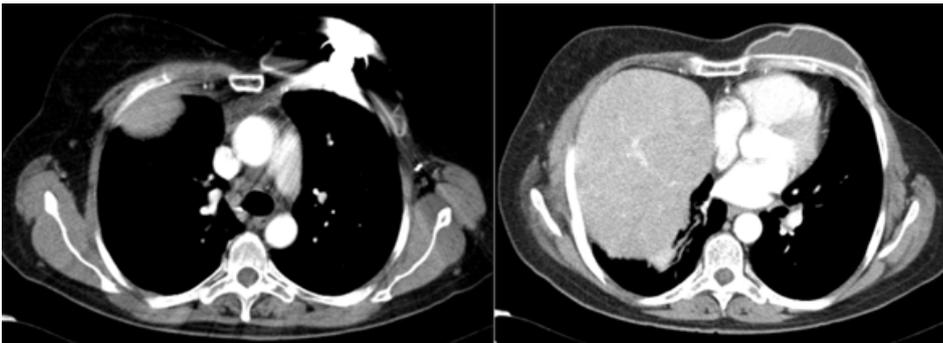
Figure 17 – A 47-year-old woman with a history of left mastectomy, showing an expander due to the presence of multiple artifacts at the level of her valve. The MRI study is contraindicated in some expanders, and its model should always be known before each exam. (<http://www.mrisafety.com/>).

This modality is used mainly in the evaluation of silicone implants, since the rupture of the saline implants in most cases is clinically evident and the fact that some expanders constitute a contraindication to its realization (Figure 17).

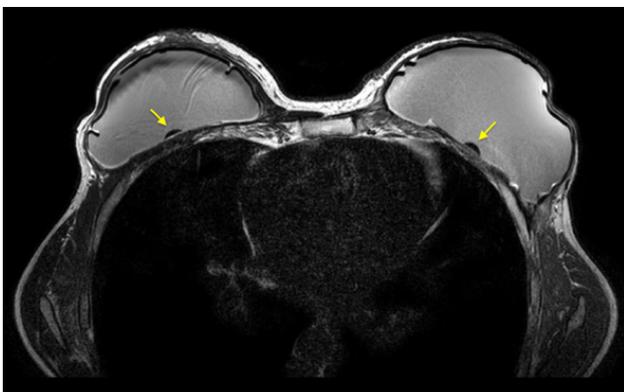
Figure 18 – MRI of 47-year-old woman submitted to left mastectomy in 2015, with symmetrization mammoplasty and placement of bilateral implants. In this sequence (T2) it is possible to verify the intermediate signal of the silicone of the implants and the presence of orientation markers (arrows).

valve with the markers used for its orientation during the surgical procedure (Figure 18).

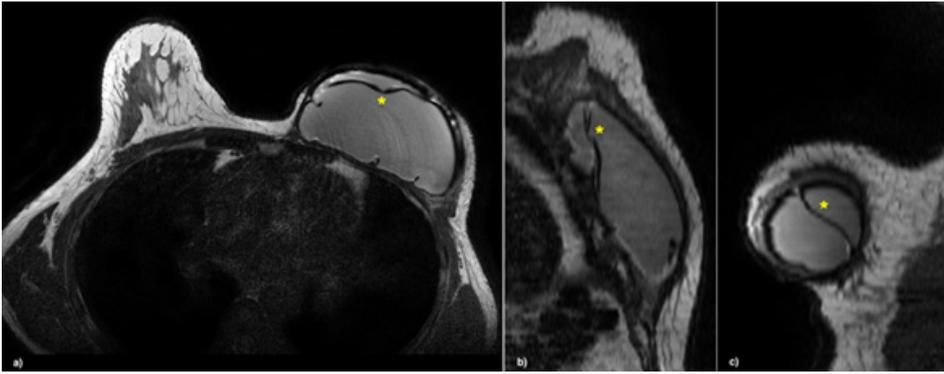
Figure 19 – A 38-year-old female with left mastectomy and reconstruction with a *Latissimus dorsi* flap and implants. The evaluation of the MRI study demonstrated the presence of what appeared to be the “sign of the subcapsular line” suggesting intracapsular rupture in the axial plane (a). Its evaluation in the other orthogonal planes (coronal (b) and sagittal (c)) revealed a pitfall, conditioned by the presence of a complex radiating fold.

These can be simple or complex, being one of the main pitfalls in the evaluation of eventual intracapsular rupture (Figure 19).

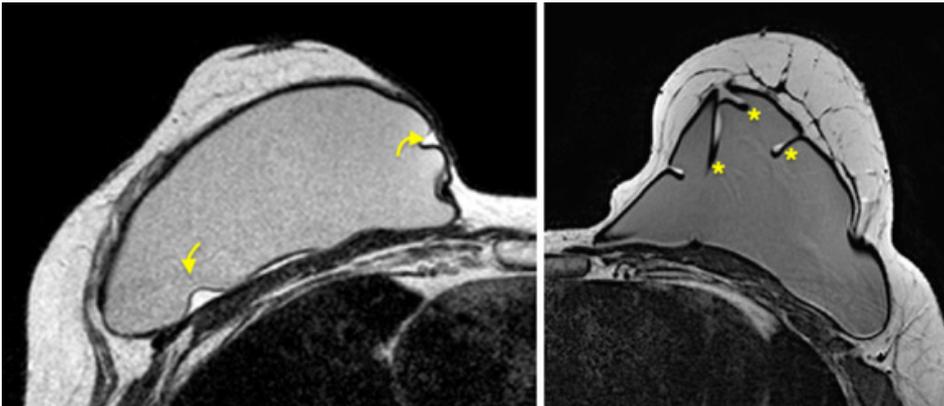
Figure 20 – Changes in the normal spectrum of mammary implants in the MRI study (T2-weighted sequence), namely the presence of undulations and minimal amount of periosthetic fluid (arrows) and the presence of radiating folds (asterisks).

The undulations of the prosthetic contour are a finding with no pathological significance, resulting from the process of adapting a malleable implant to the surgical loca. Radial folds, as well as the presence of a small amount of peri-prosthetic fluid and contour curls constitute alterations in the normal spectrum of mammary implants (Figure 20).¹²

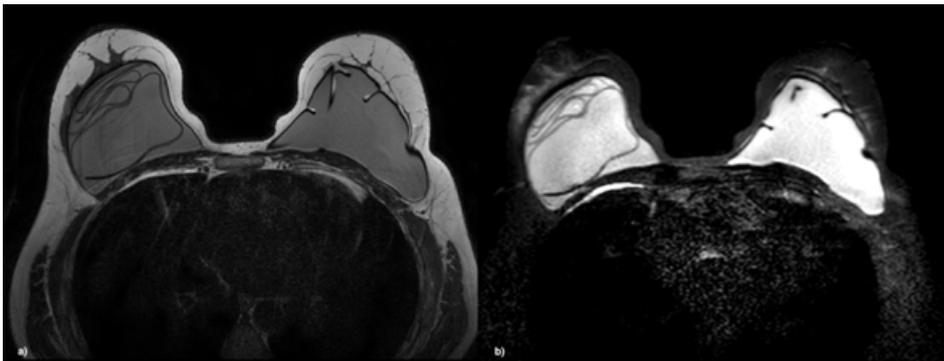
Figure 21 – MRI study revealing the presence of the “Linguini signal”, diagnosis of intracapsular rupture, evidenced in T2 (a) and selective sequence for silicone (b).

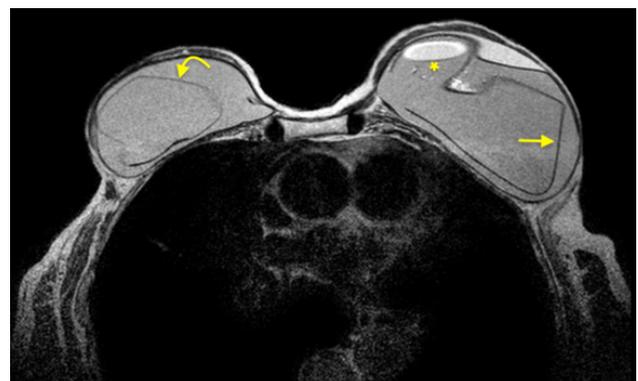
Figure 22 – An 85-year-old woman with bilateral mastectomy due to bilateral carcinoma, with reconstruction with implants 20 years ago. The MRI study revealed the presence of bilaterally intracapsular rupture signs, to the right, translated by the presence of the “subcapsular line” sign (arrow) and left by the “linguini” and “salad oil” signs (arrow and asterisk respectively).

As described in the ultrasound, there are two findings that represent earlier stages of this type of rupture, namely the locking signal (earlier) in which there is no associated collapse and the signal of the subcapsular (intermediate) line in which there may be minimal collapse of the casing. The “lock” results from the extravasation of silicone by the apex of a radiating fold, causing expansion of this region, which will later migrate into the intracapsular space, with a detachment of the inner membrane and forming the subcapsular line. The presence of some T2-weighted hypersignal foci inside the implant (“salad oil sign”) were also described as a sign suggesting this type of complication, although not a reliable signal as it may result from the injection of corticosteroids or antiseptics during the surgical procedure (Figure 22).

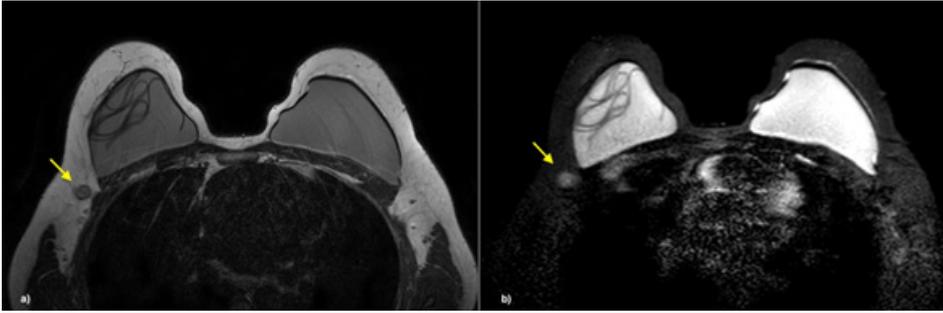
Figure 23 – MRI study of a woman with right intracapsular rupture (“linguini” sign), identifying axillary adenomegaly (arrow) in T2-weighted sequence (a), which shows hypersignal in the selective sequence of silicone (b) indicating coexistence of extracapsular rupture.

outside the fibrous capsule should be performed whenever an intracapsular rupture is detected. In MRI this is translated by the presence of foci with a signal identical to that of silicon in the sequences dedicated to its evaluation. When confluent, they may form silicone granulomas, which, like malignant lesions, may undergo growth and display enhancement after administration of contrast, being practically indistinguishable only by imaging techniques. In these cases, a directed ultrasound study should be performed in an attempt to identify the snowstorm signal, and in the absence of this, a biopsy should be performed. As with other imaging techniques, lymph nodes may also exhibit the same signal as silicone, but are not pathognomonic of extracapsular rupture (Figure 23).¹⁴

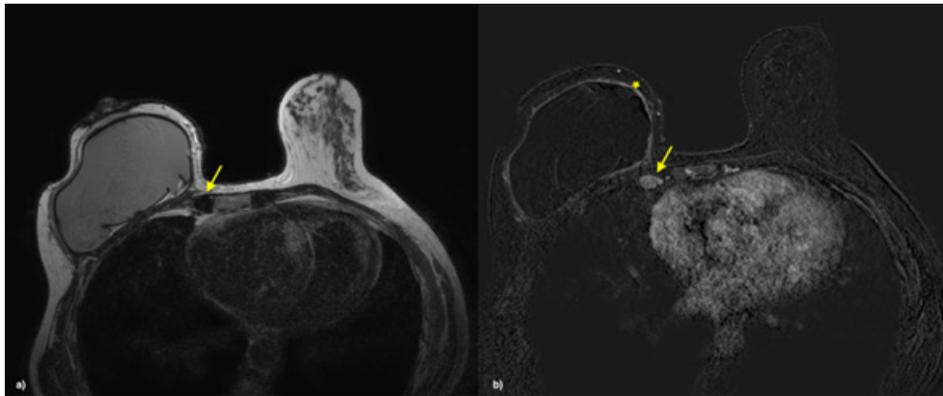
Figure 24 – A 46-year-old woman with a history of right-sided breast cancer with reconstruction with breast implant. The MRI study revealed the presence of adenomegaly in the right internal mammary chain (arrow), evidenced in the weighted sequence in T2 (a) and T1 after contrast (b). Concomitantly, there is an early and diffuse enhancement of the fibrous capsule (asterisk), in a probable relation with the underlying inflammatory process, thus explaining the reactive nature of the identified adenomegaly.

this lymphatic chain in up to one third of women with silicone implants. Of the 207 women with adenomegalies studied, only one of them revealed metastatic adenopathy. Thus, this finding should be classified as BIRADS 3, guaranteeing a short-term evaluation for 2 years, in detriment of the biopsy (Figure 24).^{6,22}

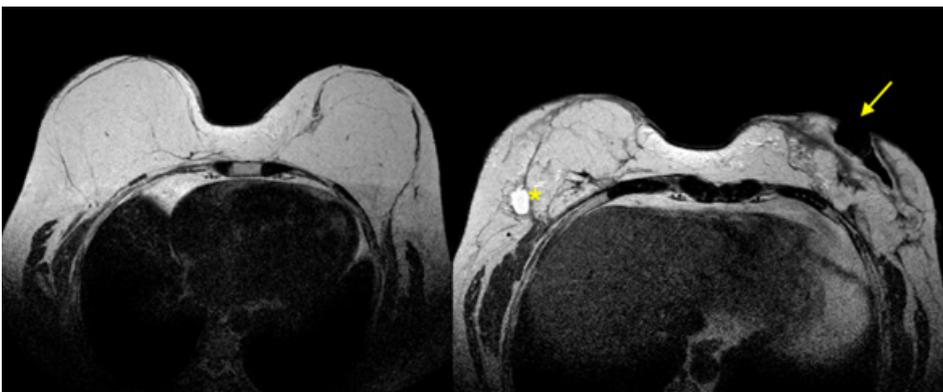
Figure 25 – A 55-year-old woman with a history of oncoplastic surgery with rectus abdominis muscle flap (TRAM). The MRI study revealed the presence of a small seroma on the right (asterisk) and the presence of cutaneous necrosis and dehiscence of the left suture (arrow).

chemotherapy and / or radiotherapy, as well as to the type of reconstruction. The early complications are similar to those observed after augmentation mammoplasty, adding cutaneous necrosis and dehiscence of the suture.²⁴ A complication frequently related to TRAM is fat necrosis, occurring in 15% of cases. Other complications include total or partial necrosis of the flap (0.3% and 2-6%) and abdominal wall herniation (Figure 25 and 26).⁶

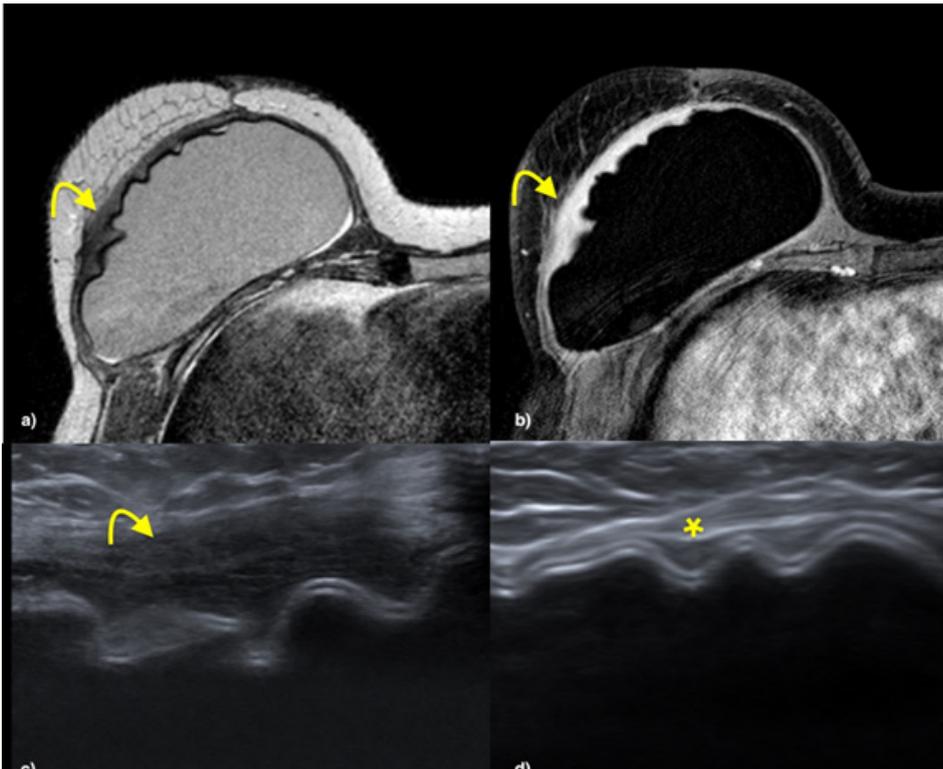
Figure 26 – A 42-year-old female with a history of breast carcinoma on the right with breast reconstruction with a *Latissimus dorsi* flap and implant. The MRI study demonstrated marked thickening of the muscle flap (a), with diffuse enhancement after administration of contrast (b) in relation to the local inflammatory process. The complementary ultrasound study (c) was concurrent, and a favorable clinical course was observed after antibiotic therapy and anti-inflammatory therapy, with disappearance of these findings in the ultrasound of control at 3 months (d).

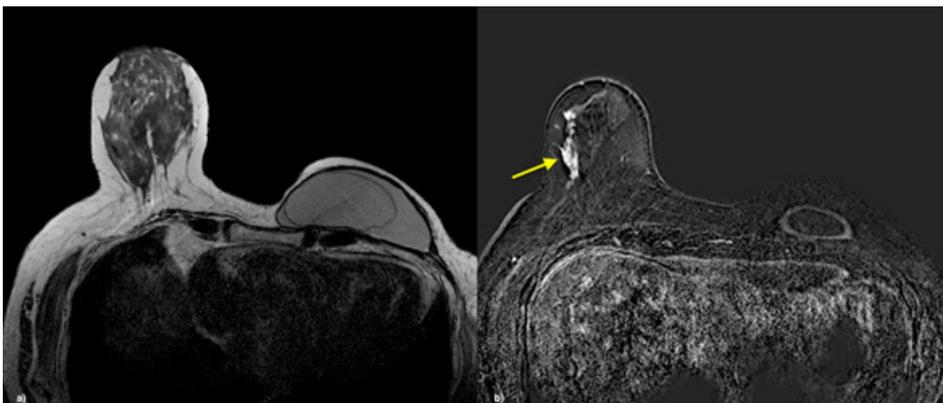
Figure 27 – A 71-year-old woman with a history of breast carcinoma on the left with breast reconstruction with a *Latissimus dorsi* flap and implant. In the MRI study, the presence of intracapsular rupture on the right was verified, identifying the signal of the subcapsular line (a). In the dynamic study after administration of contrast (b), a non-mass enhancement of the linear type was identified in the inferolateral quadrant of the contralateral breast, which after biopsy revealed a ductal carcinoma in situ.

Breast implants are not related to the increased risk of breast cancer, however they may reduce the acuity of the usual screening methods.¹² Specific mammographic incidents such as Eklund, with removal of the prosthesis and isolated compression of the mammary parenchyma, aim to increase sensitivity in the detection of lesions in women with implants. MRI is, however, the best technique for its detection, explaining the fact that the MRI protocol in women with implants includes in most cases the dynamic post-contrast study, in order to increase its detection rate (Figures 27 and 28).

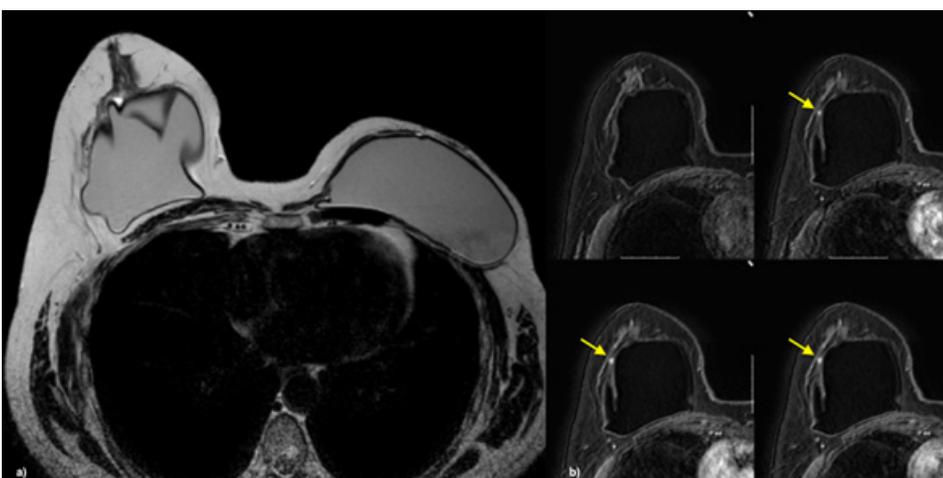
Figure 28 – Follow-up MRI in a left mastectomized woman with reconstruction with bilateral implants. Assessment of T2-weighted sequences (a) revealed no signs of prosthesis-related complications. However, in the post-contrast (b) dynamic study, the presence of a focus of enhancement was verified, which after a second-look ultrasound study and echoguided micro biopsy, an invasive ductal carcinoma was found.
