Images of Interest / Imagens de Interesse

Pulmonary Cement Embolism

Margarida Morgado^{1,2}, Ana Teresa Vilarés^{1,2}, Filipe Barros Alves^{1,2}, Ricardo Castro¹, António J. Madureira^{1,2}

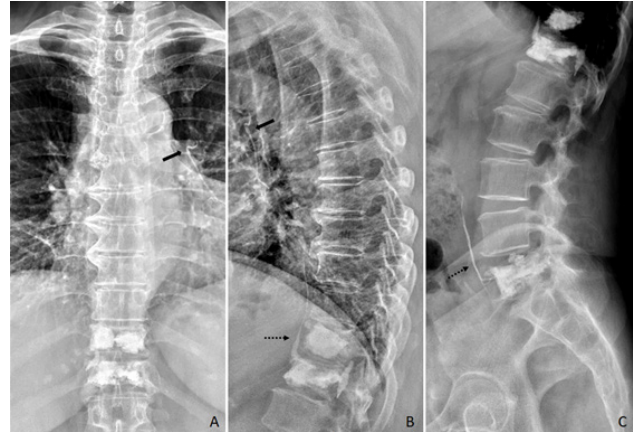
Figure 3 – Postoperative thoracic and lumbar spine radiographs after vertebroplasty and kyphoplasty of T11, T12 and L5 demonstrate radio-dense linear opacities on the left peri-hilar region (arrow, **A** and **B**) and on the anterior paravertebral region (dashed arrow, **B** and **C**) consistent with leaked bone cement within the left pulmonary artery and its posterior and descending branches, the azygos vein, the left common iliac vein and the inferior vena cava.

These findings were consistent with pulmonary cement embolism after percutaneous vertebroplasty and kyphoplasty. (Fig. 3)
