Radiological Case Report / Caso Clínico

Unusual Placement of a Central Venous Catheter in the Left Lung: Case Report

¹Serviço de Radiologia, Unidade de Saúde Local Lisboa Ocidental, Lisboa, Portugal

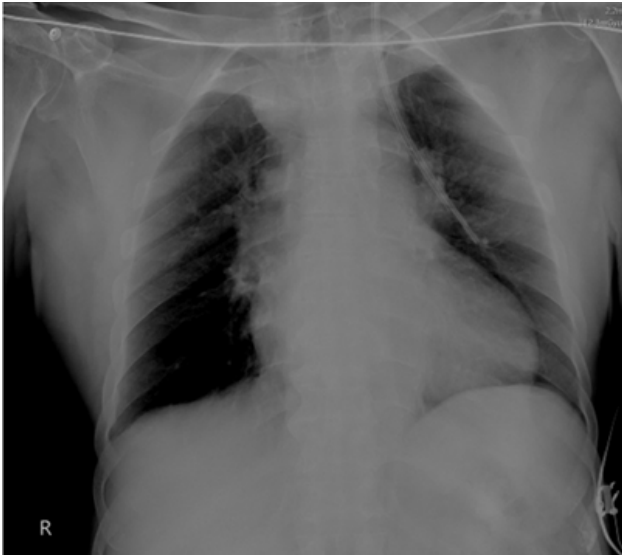
Figure 1 – Chest X-ray revealed the CVC on the left hemithorax. No signs of other iatrogenic complications were observed, such as pneumothorax, hemothorax, or tracheal deviation.

During the procedure, oxygenated blood was aspirated from both lumens, confirmed by arterial blood gas analysis. A chest X-ray revealed the CVC on the left hemithorax. No signs of iatrogenic complications such as pneumothorax, hemothorax, or tracheal deviation were observed (Fig. 1). The patient remained hemodynamically stable throughout the procedure.

The misplacement of a CVC is an uncommon but clinically significant complication. In this case, arterialized blood aspiration was the first indication of an anomalous trajectory. The radiographic evaluation revealed CVC misplacement in the left hemithorax.

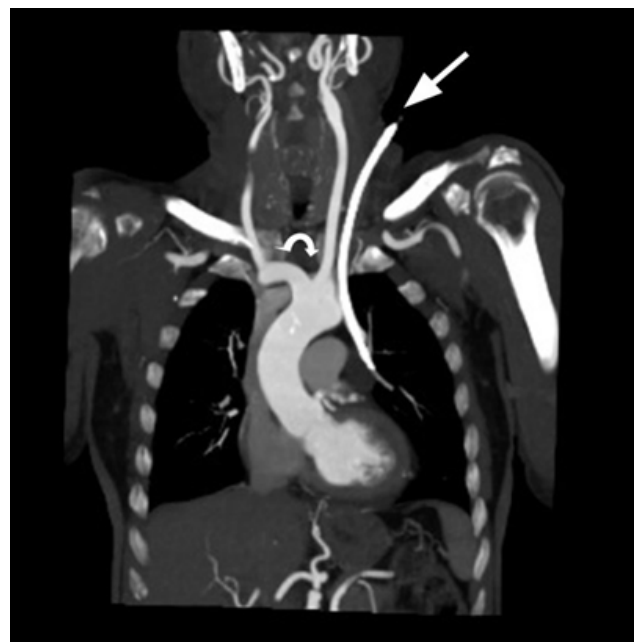
Figure 3 – Coronal CT scan with soft tissue window showing the trajectory of the catheter entering the left jugular vein and then the left superior pulmonary vein (straight arrow). An additional anatomical variant is noted, characterized by a common origin of the right brachiocephalic trunk and the left common carotid artery, commonly referred to as a bovine arch (curved arrow).

- The left-sided CVC was noted entering the left internal jugular vein, descending through the left brachiocephalic vein, and subsequently passing into the left superior pulmonary vein, with its distal tip located in an anterior segmental venous branch of the superior lobe of the left lung. No active contrast extravasation from arterial or venous sources was observed (Fig. 2a, 3, 4).

- No pneumothorax (Fig. 2b), pleural effusion, or pericardial effusion was observed (Fig. 3).

Additionally, the CT scan revealed an anatomical variant with a common origin of the right brachiocephalic arterial trunk and the left common carotid artery (bovine arch).

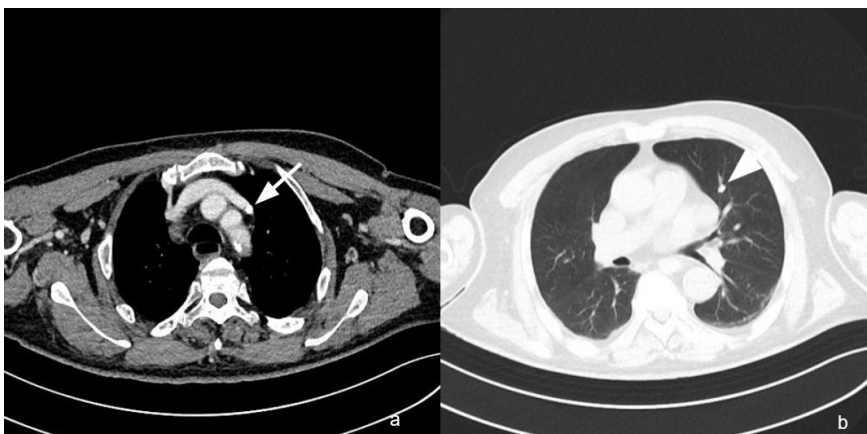
Figure 2 – a) – Axial CT scan with soft tissue window showing the catheter entering the left superior pulmonary vein (arrow) that drains into the left brachiocephalic vein. **b)** – Axial CT scan with lung window showing the catheter in the left superior pulmonary vein (arrow) inside the superior lobe of the left lung. No pneumothorax or lung consolidation is present.

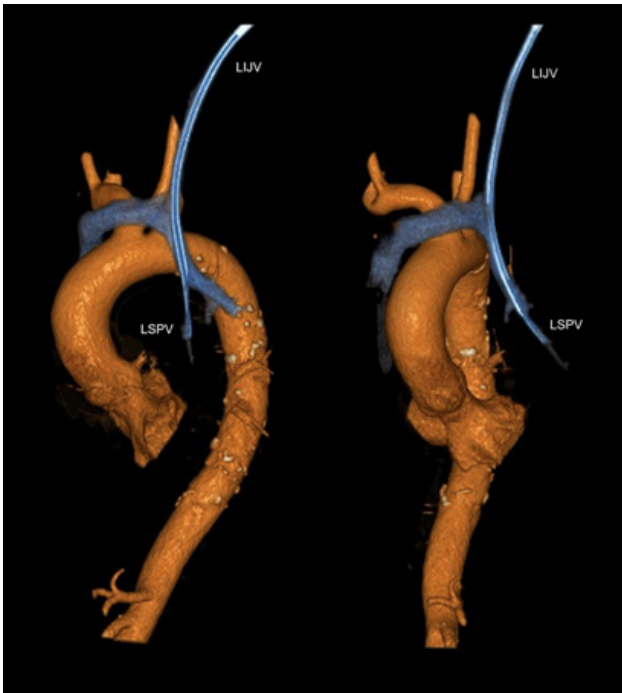
Figure 4 – 3D reconstruction showing the trajectory of the catheter entering the left internal jugular vein (LIJV) and then the left superior pulmonary vein (LSPV).

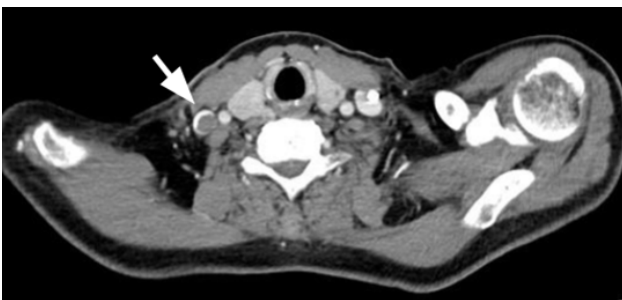
Figure 5 – The right internal jugular vein shows a contrast-filling defect consistent with thrombosis (arrow). The catheter can be seen in the lumen of the left internal jugular vein.

- There was slight soft tissue densification around the left internal jugular vein at the catheter entry site, likely related to puncture attempts.
- The right internal jugular vein showed a contrast-filling defect extending approximately 5 cm, involving its most caudal portion but sparing the confluence with the subclavian vein, consistent with thrombosis (Fig. 5).
