IMPACTS OF THE STORM *HERCULES* IN PORTUGAL

Abstract –The aim of this study is to analyse the impacts of the *Hercules* storm in Portugal. The storm occurred from January 5th to 7th, 2014. A brief characterization of the storm was conducted and the witnesses' accounts were compiled, complemented with field survey before and after the storm. The results show that this event had origin in a strong system of low pressure that hit Portugal. The system triggered strong sea waves with long periods, run-ups between 6 to 9 m, and inundation depths mostly under 1 m. The effects on the Portuguese coastline showed some weaknesses in the spatial planning management: (i) the fact that a wave train restricted to the beaches, front streets, ports and marinas caused significant damage; (ii) some people ignored the emergency management authorities, putting themselves in a risk situation.

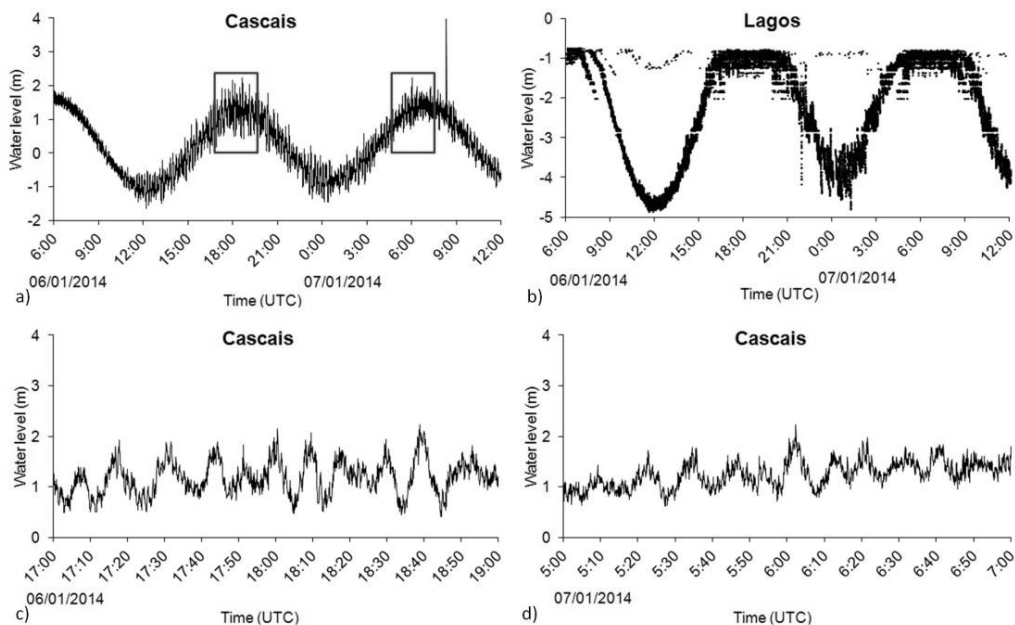
Fig. 4 – Tide gauge recordings during the *Hercules* storm: a) Cascais; b) Lagos; c) and d) zoom of Cascais data: second high tide on of January 6th (c) and first high tide on January 7th (d).

The most significant impacts occurred on the evening of January 6th and in the early morning of January 7th during the high tides. Figure 4 shows the available tide gauge stations that recorded the *Hercules* storm (www.ioc-sealevelmonitoring.org) in mainland Portugal. Due to the evident unreliability displayed by the data registered at Lagos station, the authors decided to rely on the *Cascais* data set. The *Cascais* tide gauge station clearly shows that the maximum water level corresponded to the high tide of the January 6th, about 18:40 (UTC), and in the early morning of January 7th. Data also show clearly long period waveforms of about 10 minutes, a feature also observed in *meteotsunami* events.

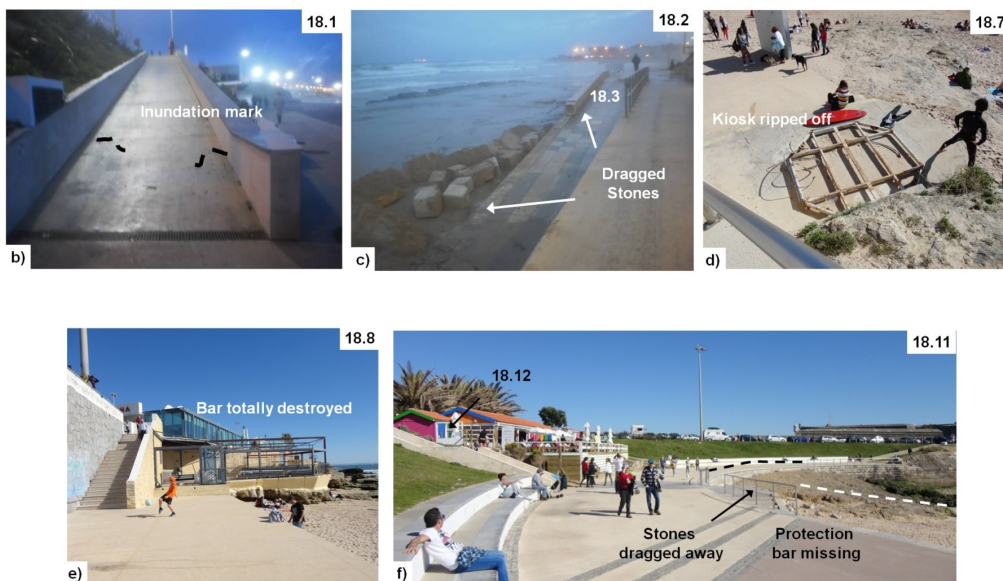
Fig. 8 – Field survey at *Carcavelos* beach: a) Framework; b) Inundation mark; c) Stones from the ramp were dragged away; d) Kiosk ripped away; e) Restaurant completely destroyed; f) Point 18.12 shows the maximum inundation area.

At *Carcavelos* (Point 18), the inundation marks (fig. 8 b) left on the sidewalk showed that the waves reached a maximum of 5.56 m (Point 18.1). The stones were displaced (fig. 8 c), at a height of 3.85 m (Point 18.3). The bars, restaurants and surf school (Point 18.4), located at a height of 5.35 m, suffered significant damage (fig. SM 8 d); in the same area there was sand erosion on the stairs and sand deposited on the ramp (fig. SM 8 b and c). On March 8th 2014, all shops were opened for business (fig. SM 8 e). The bar "Surf" (Point 18.5) which is located at 6.43 m did not suffer any damage (fig. SM 8 f), and in the evening of January 7th it was opened for business. The sand reached 6.01 m (Point 18.5), showing the waves did not inundate the sidewalk. The most significant damage was observed at the eastern part of *Carcavelos* beach (fig. SM 8 d, e, f, g, h, i): a kiosk was torn apart (Point 18.7), being located at 4.19 m height, as well as the bar "Fizz", located at 4.25 m (Point 18.8). The protection bars were ripped away on several places (Points 18.9, 18.10 and 18.11) showing the waves were higher than 5.40 m. The bar "Moinho" suffered significant damage, despite being located at a height of 6.85 m (Point 18.12). On March 8th it was opened for business.
