FINISTERRA

Volume XLIX
Número 98
Lisboa 2014

IMPACTS OF THE STORM *HERCULES* IN PORTUGAL

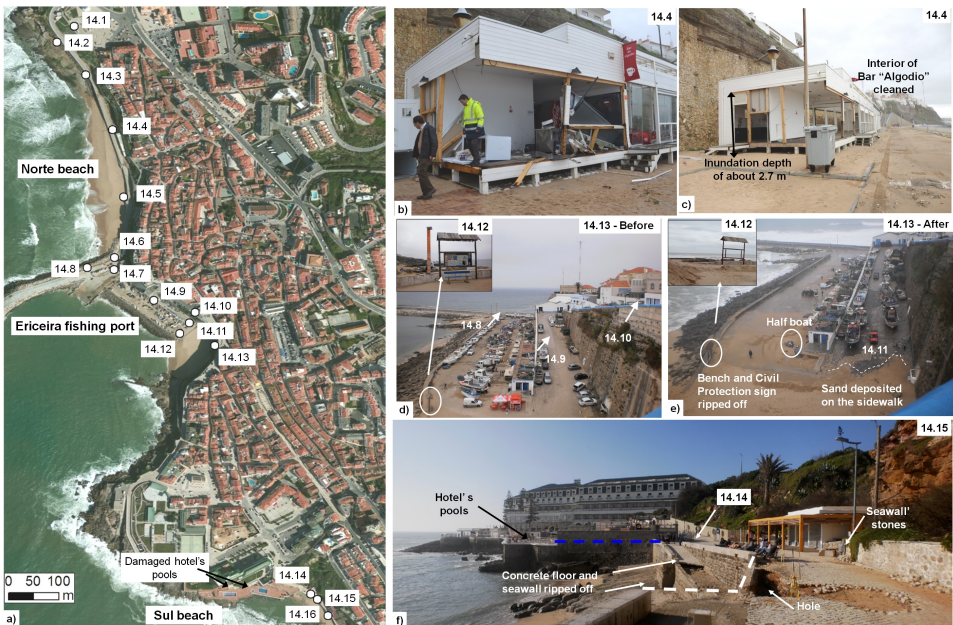
From the *Norte* beach, the waves propagated into the *Ericeira* fishing port. The naval club, located at a height of 5.19 m (Point 14.6), was completely destroyed (fig. SM 5 b, c), and on March 4th 2014 it was completely renovated (fig. SM 5 d). Two men trapped inside the club said the water level reached their necks (table I). The breakwater is 6.57 m high (Point 14.8), and the witnesses also reported that the waves passed over it. The difference in heights is 1.38 m which confirms the witnesses' accounts. On the other hand, photos taken during the storm (fig. SM 5e) and in the evening of January 7th (fig. SM 5 f) show the waves hitting the breakwater and passing over it, validating the reports (table I). In addition, photos taken before and after the storm at the fishing port (fig. 6 d, e) showed a significant deposition of sand (fig. SM 5 g) that most likely originated from the *Norte* beach. The maximum inundation level was 4.51 m (Point 14.11) whereas the ground has a height of 3.9 m (Point 14.12), which shows that the breakwater had an important role in decreasing the waves' impact on the fishing port because the inundation depth was 0.61 m only. Since the fishermen's warehouses are located on elevated ground (fig. SM 5 h) the waves did not cause significant damage inside the facilities, but the wave currents were strong enough to destroy several vessels, and ripping away a bench and the civil protection sign (fig. 6 e).

Fig. 6 – Field survey at *Ericeira*: a) Framework; b) Algodio bar destroyed; c) Bar and road cleaned from debris; d) and e) Point 14.13 before and after the storm; f) Damage at *Sul* beach.

The *Sul* beach also suffered significant damage from the waves that ripped away the concrete floor and seawall, scattering debris and stones and leaving a hole on the ground (fig. SM 6 f and 6 b, f, g). Although by March 7th the sand and debris had been cleared from the sidewalk (fig. SM 6 c), damage was still visible. The waves hit the sidewalk, breaking and increasing significantly in height (fig. SM 6 d). Photos taken after the storm showed sand deposited on the sidewalk and broken windows in a restaurant (fig. SM 6 d, e). The sidewalk is located at about 6 m high (Point 14.14, Point 14.15, and Point 14.16); the windows are located about 2 m above the ground, giving a run-up of more than 6 m. The swimming pools of the hotel, at the same level as the sidewalk, were also very damaged (fig. SM 6 h). In addition, a fishing vessel was recovered from the sea. It was found around 8 m deep, about 2 km south of *Ericeira* and about 500 m from the beach, as reported by professional divers of NDivers.

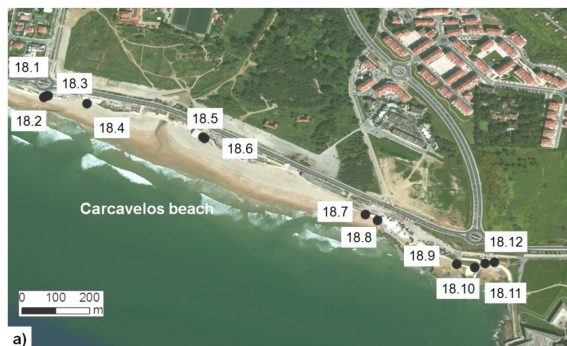
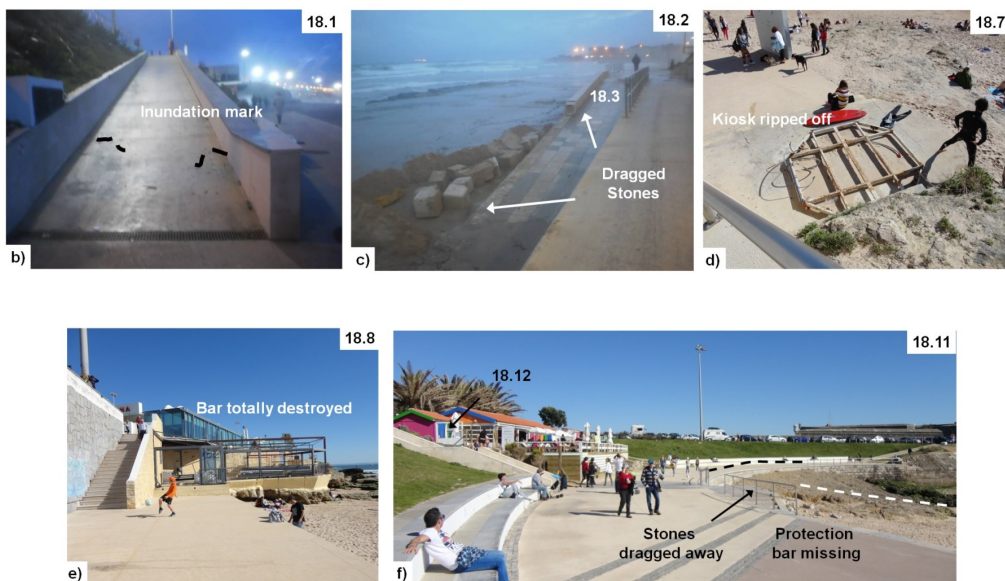
At *Carcavelos* (Point 18), the inundation marks (fig. 8 b) left on the sidewalk showed that the waves reached a maximum of 5.56 m (Point 18.1). The stones were displaced (fig. 8 c), at a height of 3.85 m (Point 18.3). The bars, restaurants and surf school (Point 18.4), located at a height of 5.35 m, suffered significant damage (fig. SM 8 d); in the same area there was sand erosion on the stairs and sand deposited on the ramp (fig. SM 8 b and c). On March 8th 2014, all shops were opened for business (fig. SM 8 e). The bar "Surf" (Point 18.5) which is located at 6.43 m did not suffer any damage (fig. SM 8 f), and in the evening of January 7th it was opened for business. The sand reached 6.01 m (Point 18.5), showing the waves did not inundate the sidewalk. The most significant damage was observed at the eastern part of *Carcavelos* beach (fig. SM 8 d, e, f, g, h, i): a kiosk was torn apart (Point 18.7), being located at 4.19 m height, as well as the bar "Fizz", located at 4.25 m (Point 18.8). The protection bars were ripped away on several places (Points 18.9, 18.10 and 18.11) showing the waves were higher than 5.40 m. The bar "Moinho" suffered significant damage, despite being located at a height of 6.85 m (Point 18.12). On March 8th it was opened for business.

Fig. 8 – Field survey at *Carcavelos* beach: a) Framework; b) Inundation mark; c) Stones from the ramp were dragged away; d) Kiosk ripped away; e) Restaurant completely destroyed; f) Point 18.12 shows the maximum inundation area.

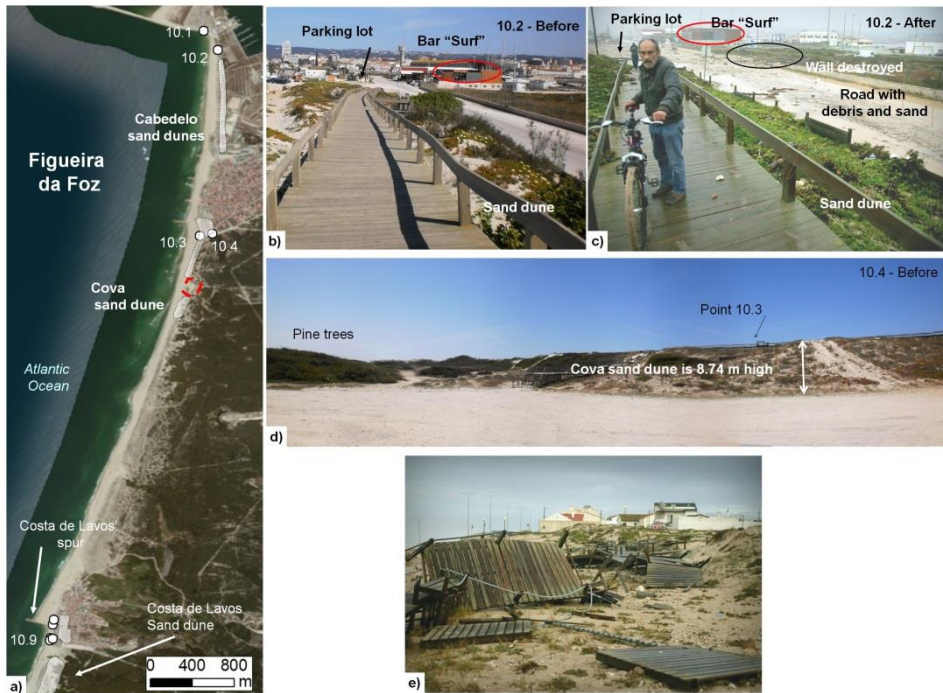
A field survey had been conducted at *Cabedelo*, *Figueira da Foz* (Point 10.1) before this storm on April 18th, 2012 (fig. 5b and SM 3b). Photos after the storm show that the waves overtopped the parking lot which is 5.67 m high (table SM I), inundating it and depositing sand and small boulders. It partially destroyed a wall near the road. The sand dune is 9.13 m high (point 10.2), and did not suffer significant damage.

The *Cova*' sand dune showed to be a natural barrier (fig. SM 3d, Point 10.3), reaching a height of 13.84 m. In 2013 part of the sand dune was showing signs of collapsing (fig. SM 2) being almost as the same level as Point 10.4 (5.10m). Although there were no structural damages on the area, the collapsed sand dune allowed the water to penetrate inland till the pine trees (fig. 5d, e).

Fig. SM 3 – Field survey at Figueira da Foz: a) Framework; b) Cabedelo sand dune before the storm; c) Cabedelo sand dune after the storm. Photo taken by Pedro A. Cruz; d) Cova sand dune; e) Damage at Costa de Lavos. Photo taken by Pedro A. Cruz.

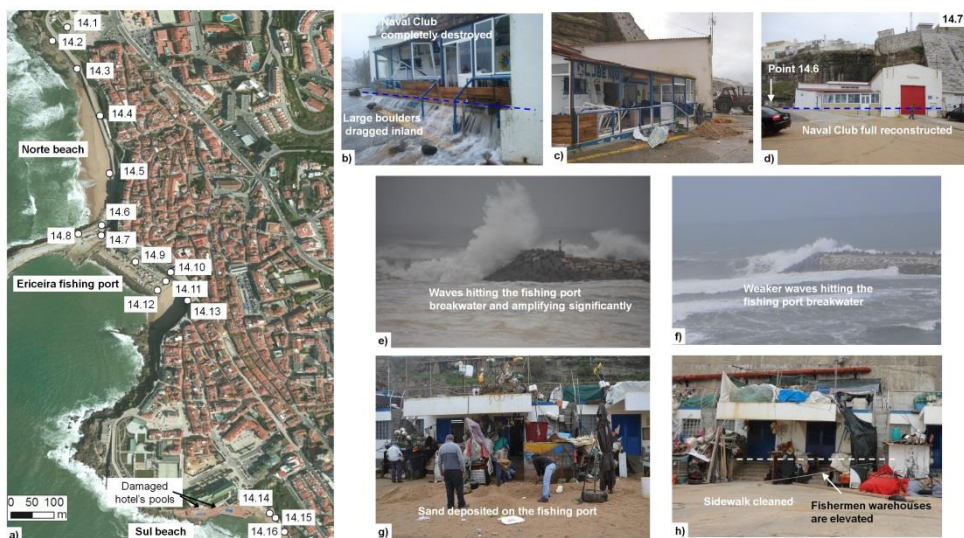
Fig. SM 5 – Field survey at Ericeira fishing port: a) Framework; b) Naval club being inundated. Photo by AZUL; c) Naval club completely destroyed. Photo by AZUL; d) Naval club reconstructed; e) Waves hitting the fishing port breakwater. Photo by AZUL; f) Weaker waves hitting the fishing port breakwater; g) cleaning operations at the fishing port. Photo by AZUL; h) fishing port cleaned.

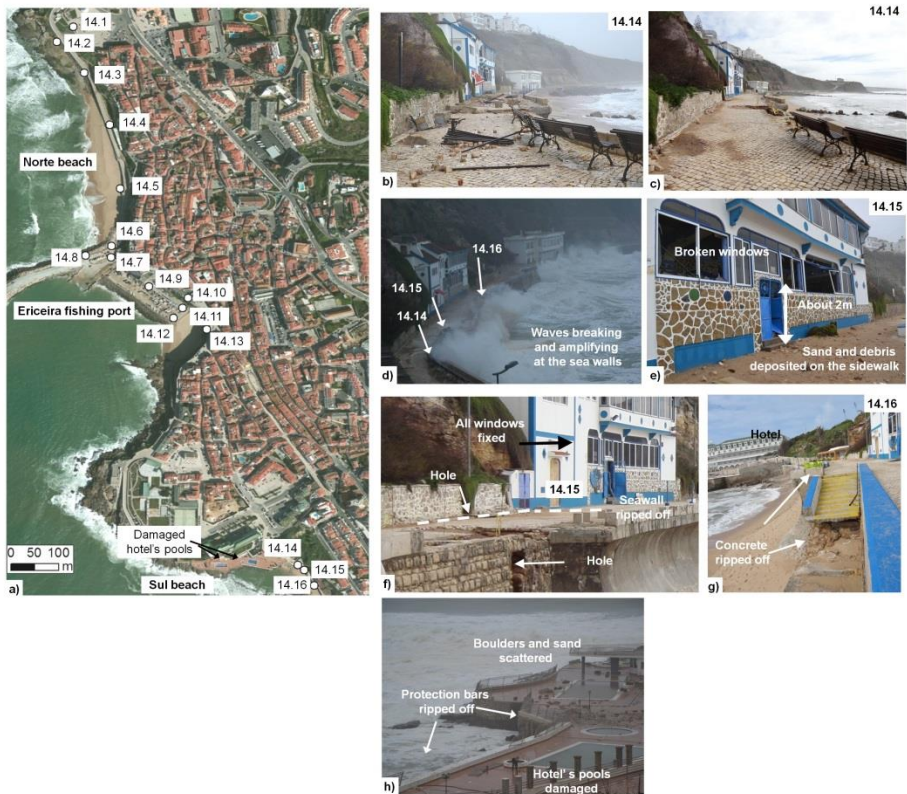
Fig. SM 6 – Field survey at Sul beach, Ericeira: a) Framework; b) damages on the Sul beach sidewalk. Photo by AZUL; c) sidewalk cleaned from debris; d) Sea waves hitting the Sul beach. Photo by AZUL; e) Damage on a restaurant. Photo by AZUL; f) Sea wall ripped off; g) Concrete structures ripped off; h) Damage on the hotel’s pools. Photo by AZUL.

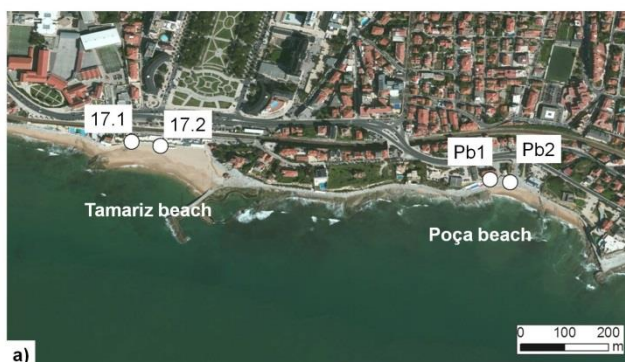
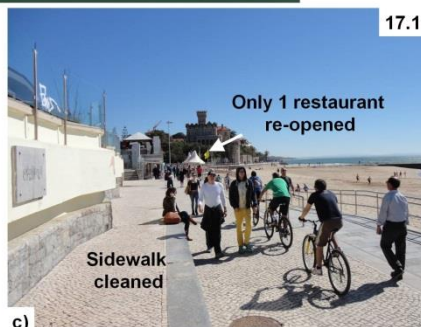
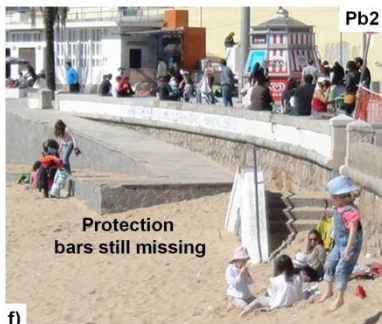
The January 7th survey showed a similar situation at *Tamariz* beach, *Estoril* (Point 17), with sand deposited on the sidewalk and stones ripped away from it (fig. 7 b and SM 7 b). The witnesses and owners of the promenade's restaurants and bars also reported damage (table I). On March 8th, 2014 everything was cleaned and repaired (fig. 7 c and SM 7 c), and one restaurant was already opened for business. Point 17.1 and 17.2 were 5.59 m and 5.00 m high, indicating the waves were at least 5.6 m high.

The media did not report any damage on the *Poça* beach, *Estoril*. Nevertheless, the first author found significant damage (fig. SM 7 d and 7 e). The inundation mark was at 6.12 m (Point Pb1). The sidewalk is 5.40 m high therefore the local inundation depth was 0.72 m, enough to scatter the sea wall stones on the sidewalk. On March 8th, 2014 the protection bars were still missing (fig. SM 7 f), but new stones were already available on site to rebuild the area.

Fig. SM 7 – Field survey at Tamariz and Poça beaches, Estoril: a) Framework; b) Sand deposited on the sidewalk; c) Sidewalk cleaned; d) Inundation mark; e) Protection bars ripped off; f) damage still visible.

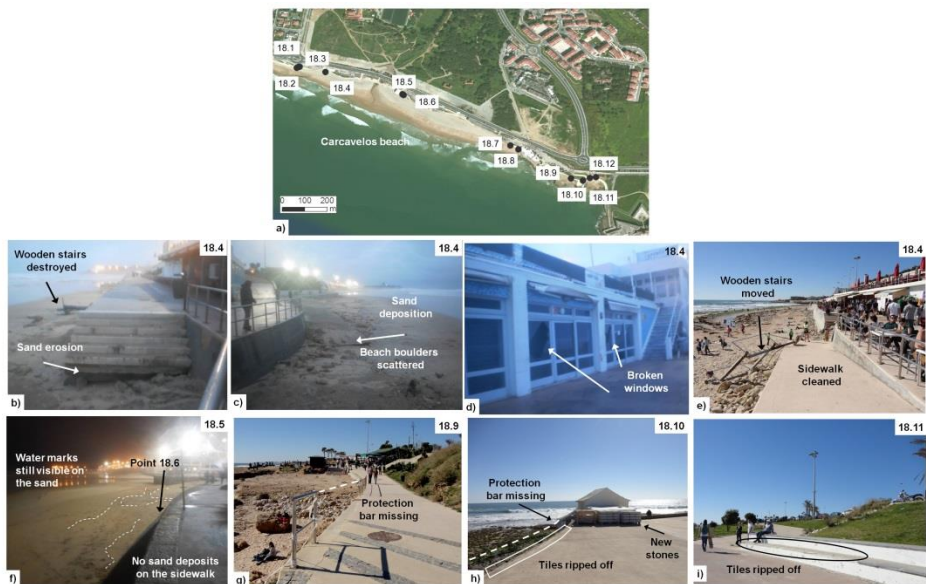
Fig. SM 8 – Field survey at Carcavelos beach: a) Framework; b) Erosion at the base of stairs; c) sand and boulders deposited; d) restaurants damaged; e) sidewalk cleaned, but damage was still visible; f) inundation marks at the beach; g) Protection bars still missing; h) Protection bars still missing and tiles ripped off; i) Tiles of the sidewalk ripped off.
